REMOVAL PROGRAM AFTER ACTION REPORT FOR THE PARK STREET SITE BENNINGTON, BENNINGTON COUNTY, VERMONT 17 SEPTEMBER 2012 THROUGH 12 JULY 2013

U.S. Environmental Protection Agency Region I Emergency Planning and Response Branch 5 Post Office Square, Suite 100 Boston, Massachusetts 02109-3912

Weston Solutions, Inc.
Superfund Technical Assessment and Response Team III (START)
3 Riverside Drive
Andover, Massachusetts 01810

September 2013

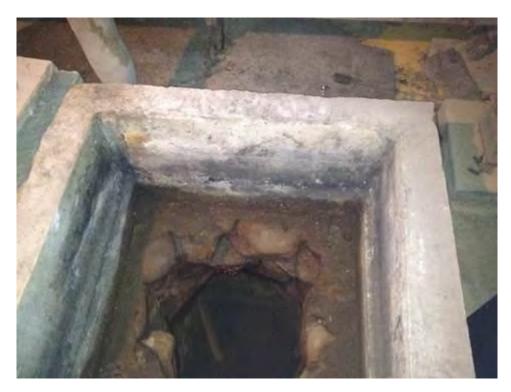
SCENE: View of a well located in the basement at (b) (6). Photograph was taken prior to decontamination.

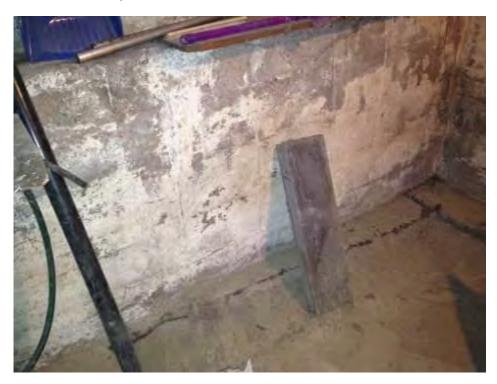
SCENE: View of the northern basement wall at (b) (6) prior to decontamination.

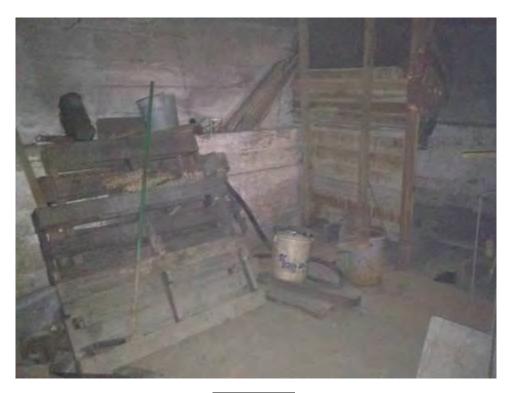
SCENE: View of the northwestern basement walls at (b) (6) prior to decontamination.

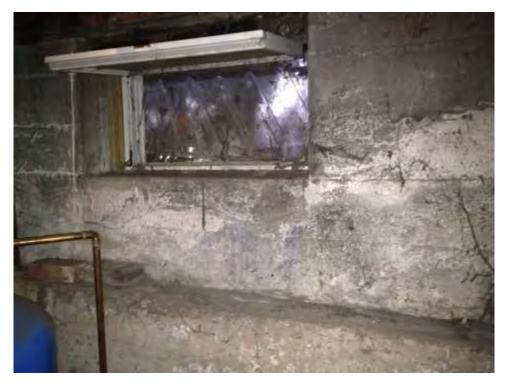
SCENE: View of a window located on the southern basement wall at (b) (6) prior to decontamination.

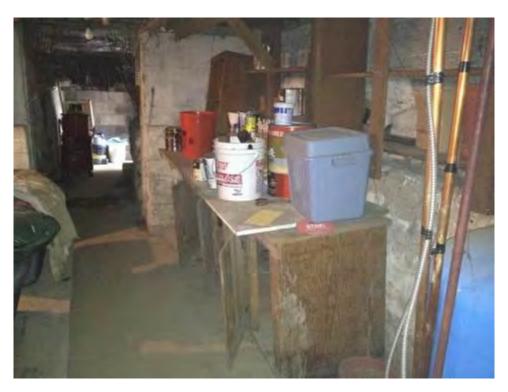
SCENE: View of a basement wall at (b) (6) prior to decontamination.

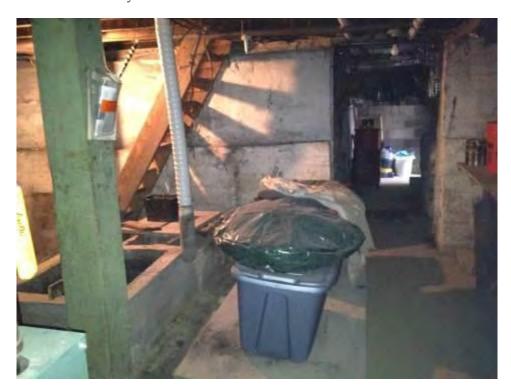
SCENE: View of the central and eastern area in the basement at (b) (6) prior to decontamination.

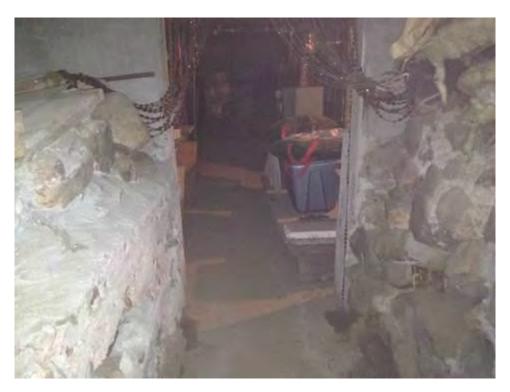
SCENE: View of a hall leading from the bulkhead door to the main basement at (b) (6). Wet areas are visible at the

base of the stone foundation wall.

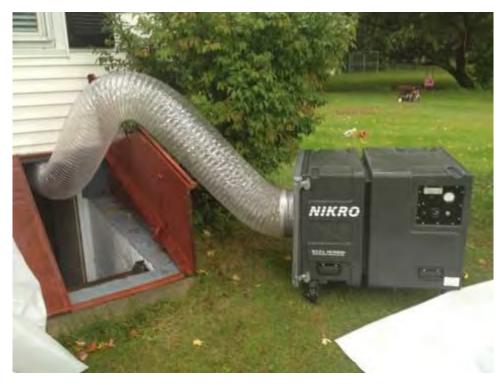
SCENE: View of the negative air system used during decontamination operations at (b) (6)

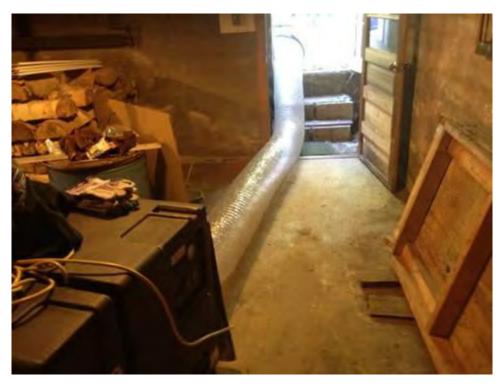
SCENE: View of the negative air system set up at (b) (6) during decontamination activities.

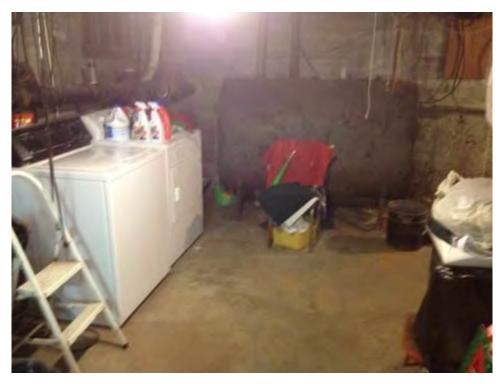
SCENE: View of the western central basement area at (b) (6) prior to decontamination.

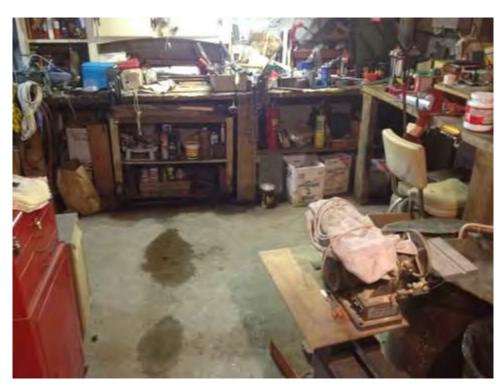
SCENE: View of the southeastern basement area at (b) (6) prior to decontamination. Water is visible on the floors.

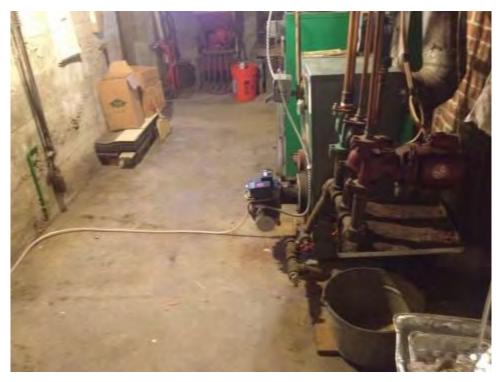
SCENE: View of the central basement area located behind the stairwell at (b) (6). The photograph was taken prior to decontamination activities.

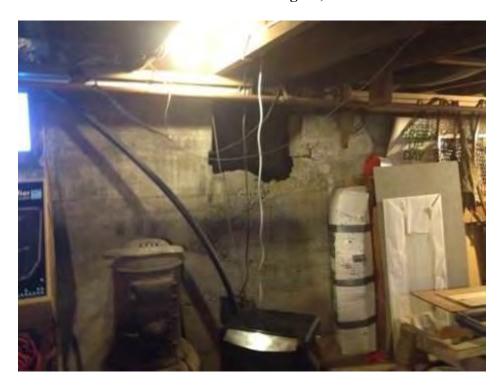
SCENE: View of a hole in the northern basement wall at

decontamination.

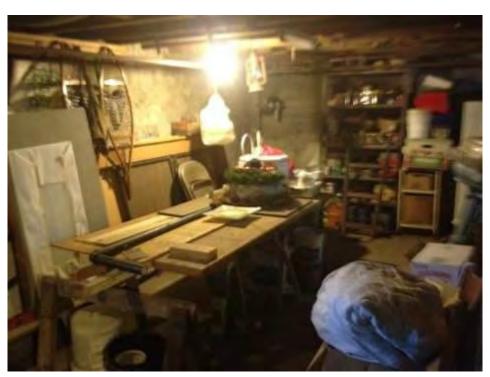
SCENE: View of the northeastern basement area at **(b) (6)** prior to decontamination.

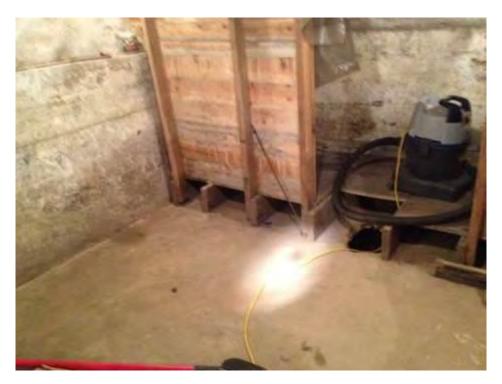
SCENE: View of northwestern basement area at (b) (6) following decontamination.

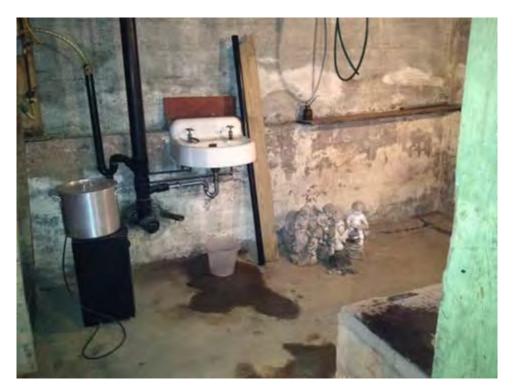
SCENE: View of the northeastern basement area at (b) (6) following decontamination.

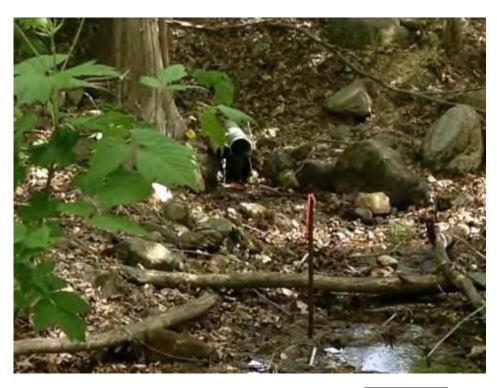
SCENE: View of suspected effluent piping from the former sump pump system of (b) (6). Photograph taken facing

south.
